England's Heritage in Stone

Proceedings of a Conference

Building stone as a resource

- finding stone for restoration projects

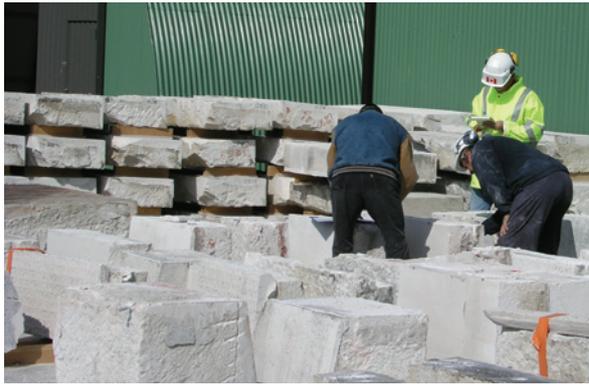
Fig. 2. Matching the stone at Vimy

Samples of the stone were collected and tested, and proved to be a very good match and to be sufficiently durable to be a good choice for the restoration (Fig. 2). Despite the success in sourcing the stone, difficulties were encountered in actually obtaining stone for the restoration

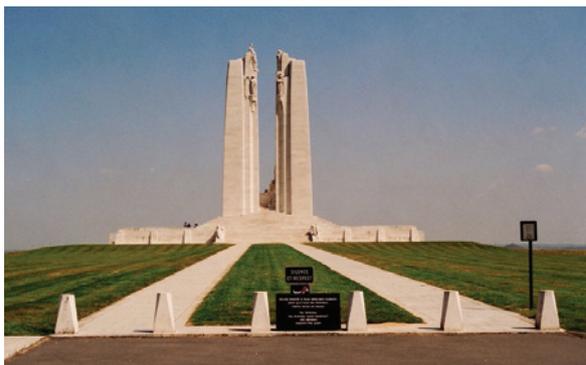
Fig. 3. The Vimy Ridge Memorial restored

project due to arguments over the ownership of the quarry and the availability of the stone, which resulted in long delays in the actual restoration work. However, it is now complete and the site was re-dedicated in April 2007 on the 90th anniversary of the assault on the Ridge (Fig. 3).

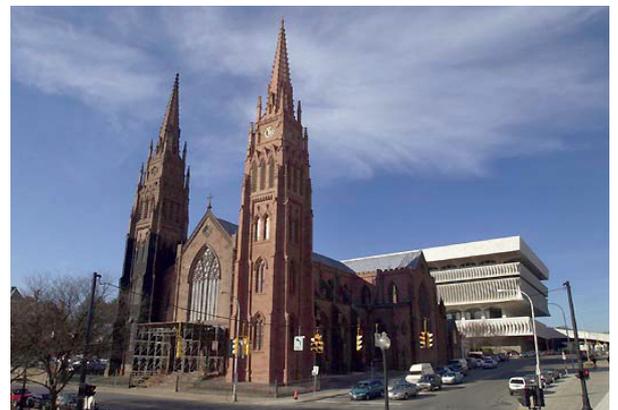
Fig. 4. Albany Cathedral, New York

The Cathedral of the Immaculate Conception, Albany, New York State (USA) was initially constructed between 1848 and 1852 (Fig. 4). The design was by Patrick Charles Keeley and was inspired by Cologne Cathedral. The north spire was constructed in 1862 and the south spire in 1887. The cathedral was completed in 1892 with the construction of the sanctuary and sacristies at the west end. The cathedral is now part of a major urban area and the stonework has decayed – particularly the more exposed stonework in the spires and the clerestory – and by 2000 it was in need of replacement.
